BUREAU OF YARDS AND DOCKS WASHINGTON D C

AEC-WT-91

Since protective construction is a problem common to civil as well as military installations, practical methods of design and analysis for blast loadings must be developed for use by structural engineers. The method of design and analysis used in Project 3.2 was developed for practical use by A. Amirikian, Consultant on Special Structures for the Bureau. The complete postshot analysis for two of the most important structures may be found in Chap. 7. The remaining structures will be analyzed as time permits.

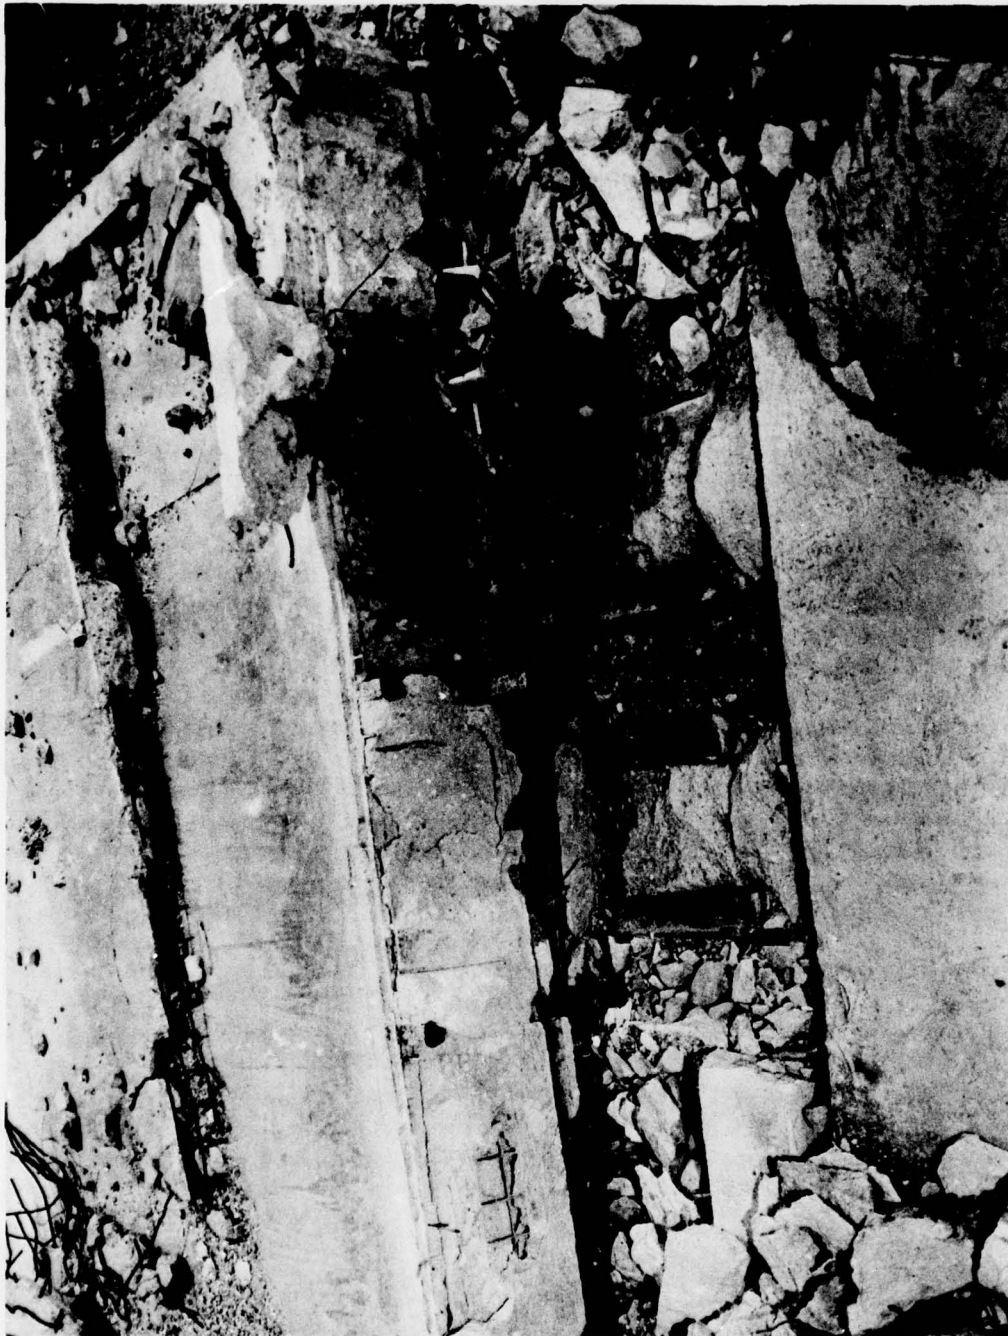
Fig. 6.51 Right End Wall of Structure 3.2.3a, Showing Failure at Welds Between Truss-chord Bars and Channel. Second truss from the right failed in the weld; the rest sheared out the parent metal of the channel at the weld location.

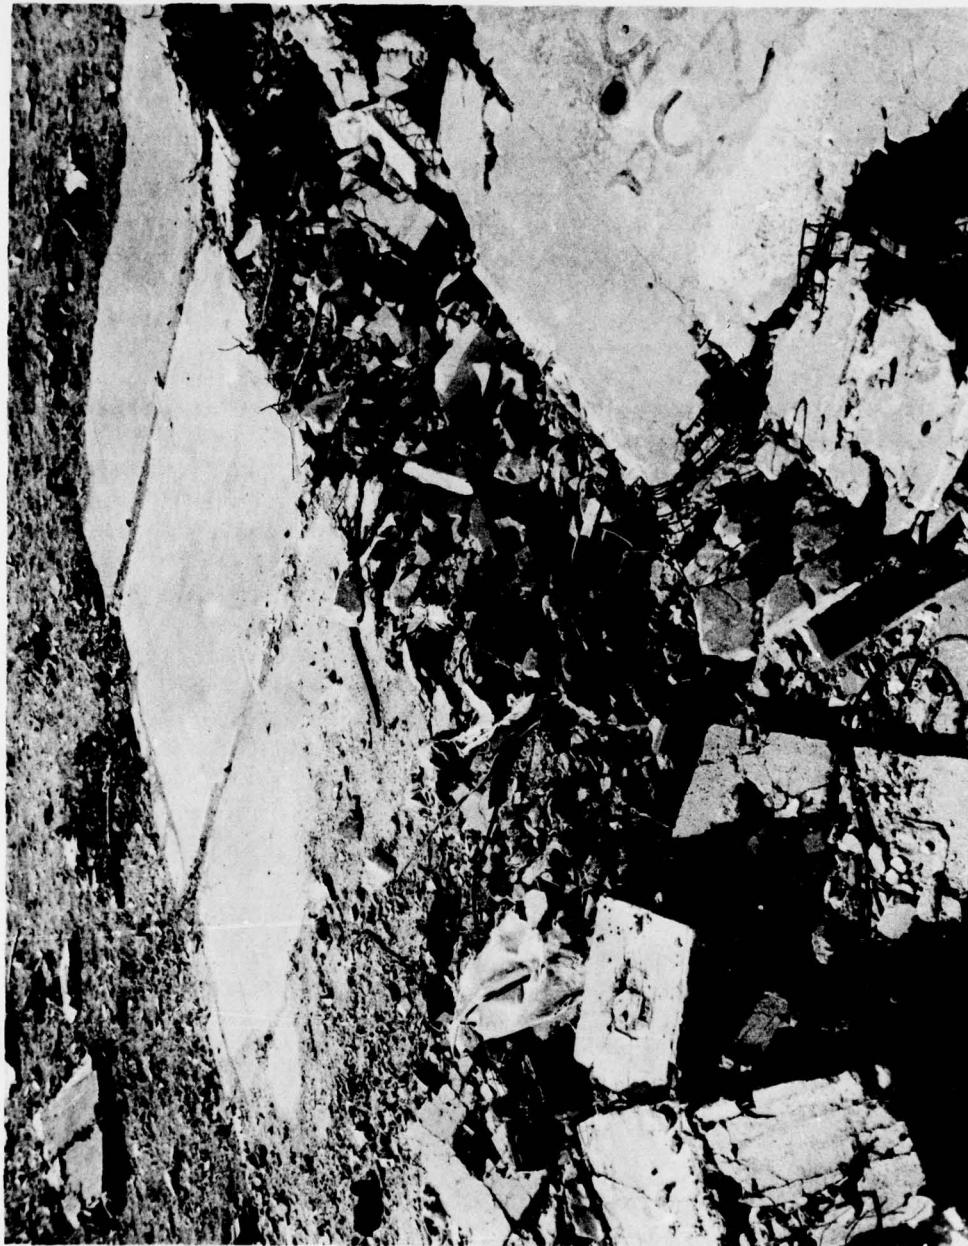
Fig. 6.53 Base of Rear Wall of Structure 3.2.3a Still Attached to Foundation. Lower row of cells collapsed. Weld failures of inside truss bars can be seen in right center of photograph. Panel in right foreground and other debris are from front wall.

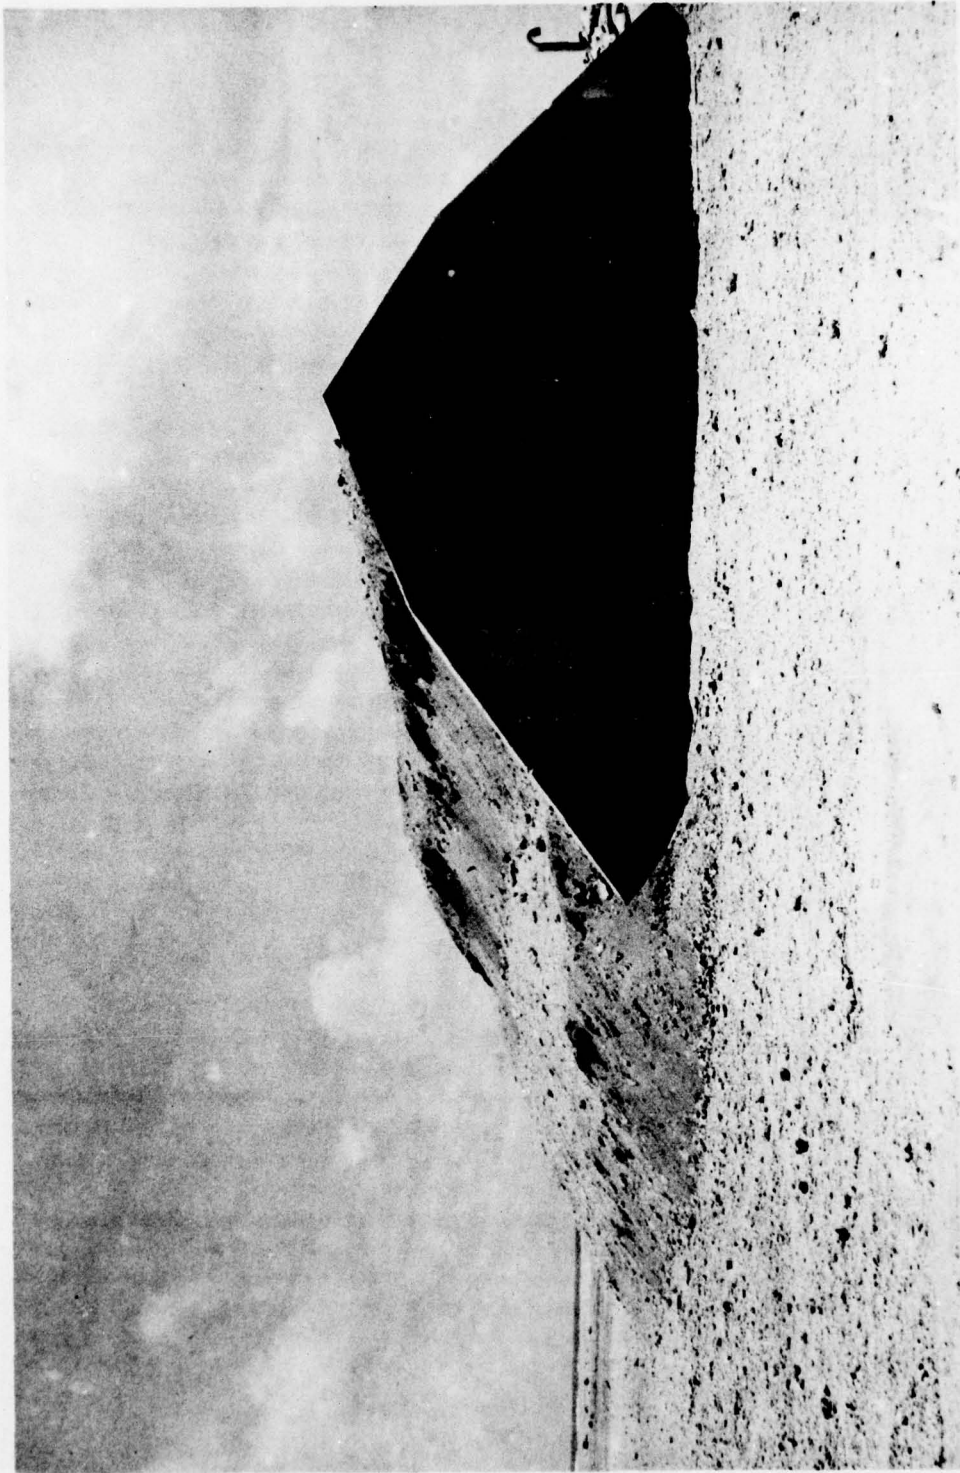
Fig. 6.61 View of Right End of Structure 3.2.4a. This end wall was blown into the building.

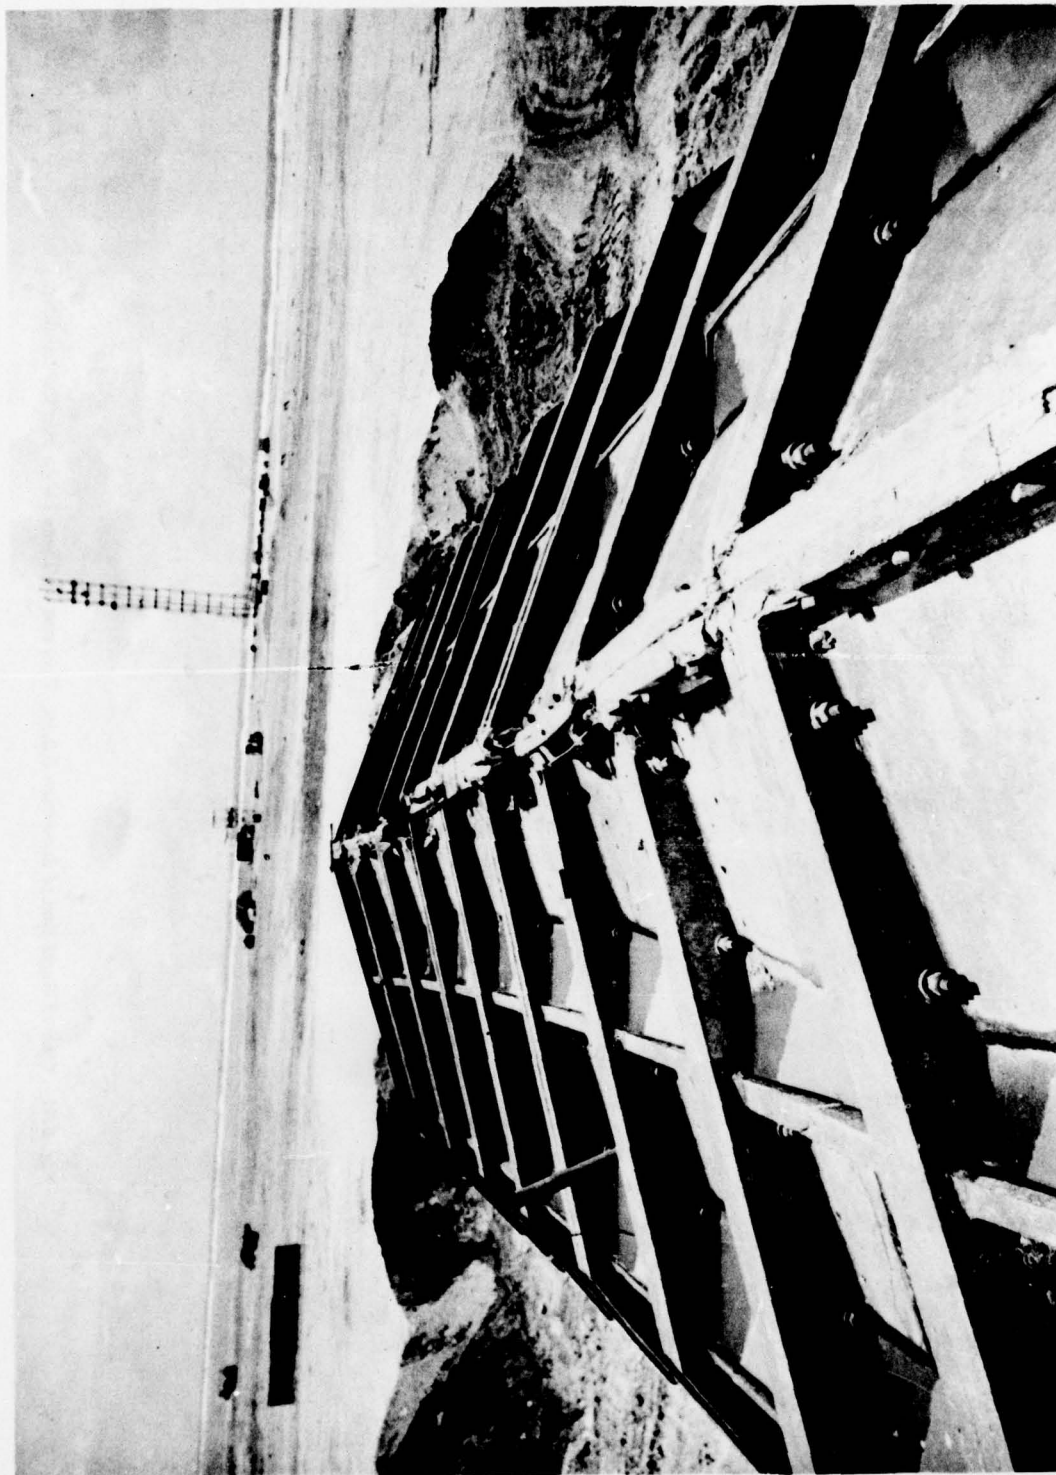
Fig. 6.62 Failure of Crown Joint in Central Two-thirds of Structure. Joint in foreground has only moderate damage; damage increases in panels near center and decreases again at the far end.

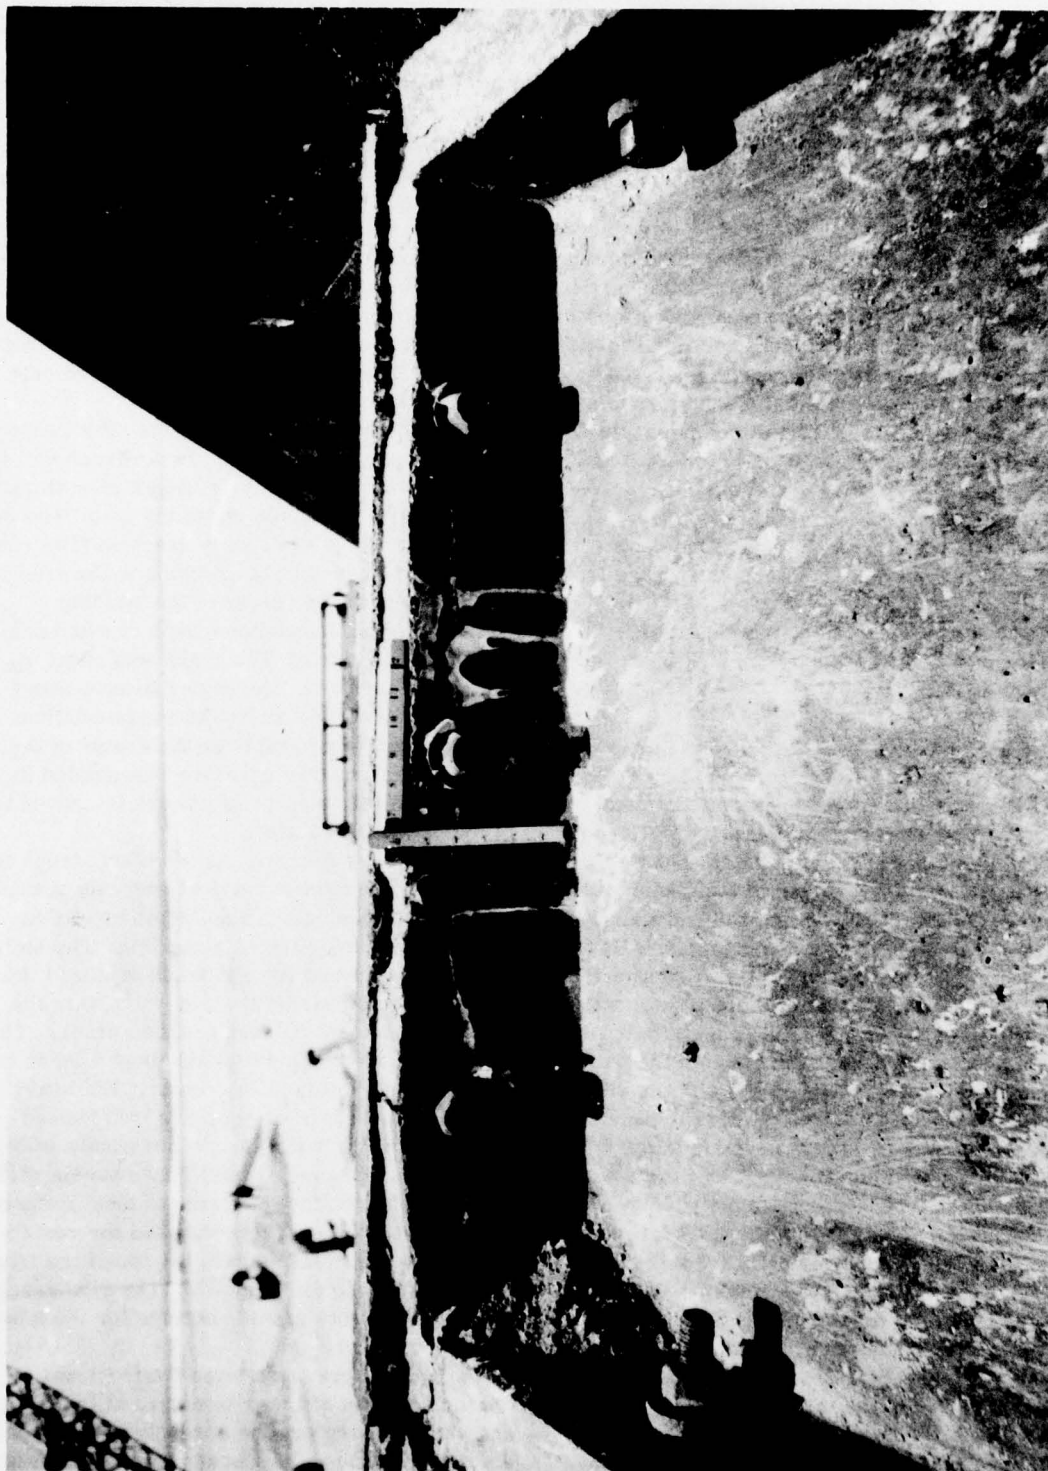
Fig. 6.65 Crown Failure near Right End, Showing Downward Movement of Front Panel

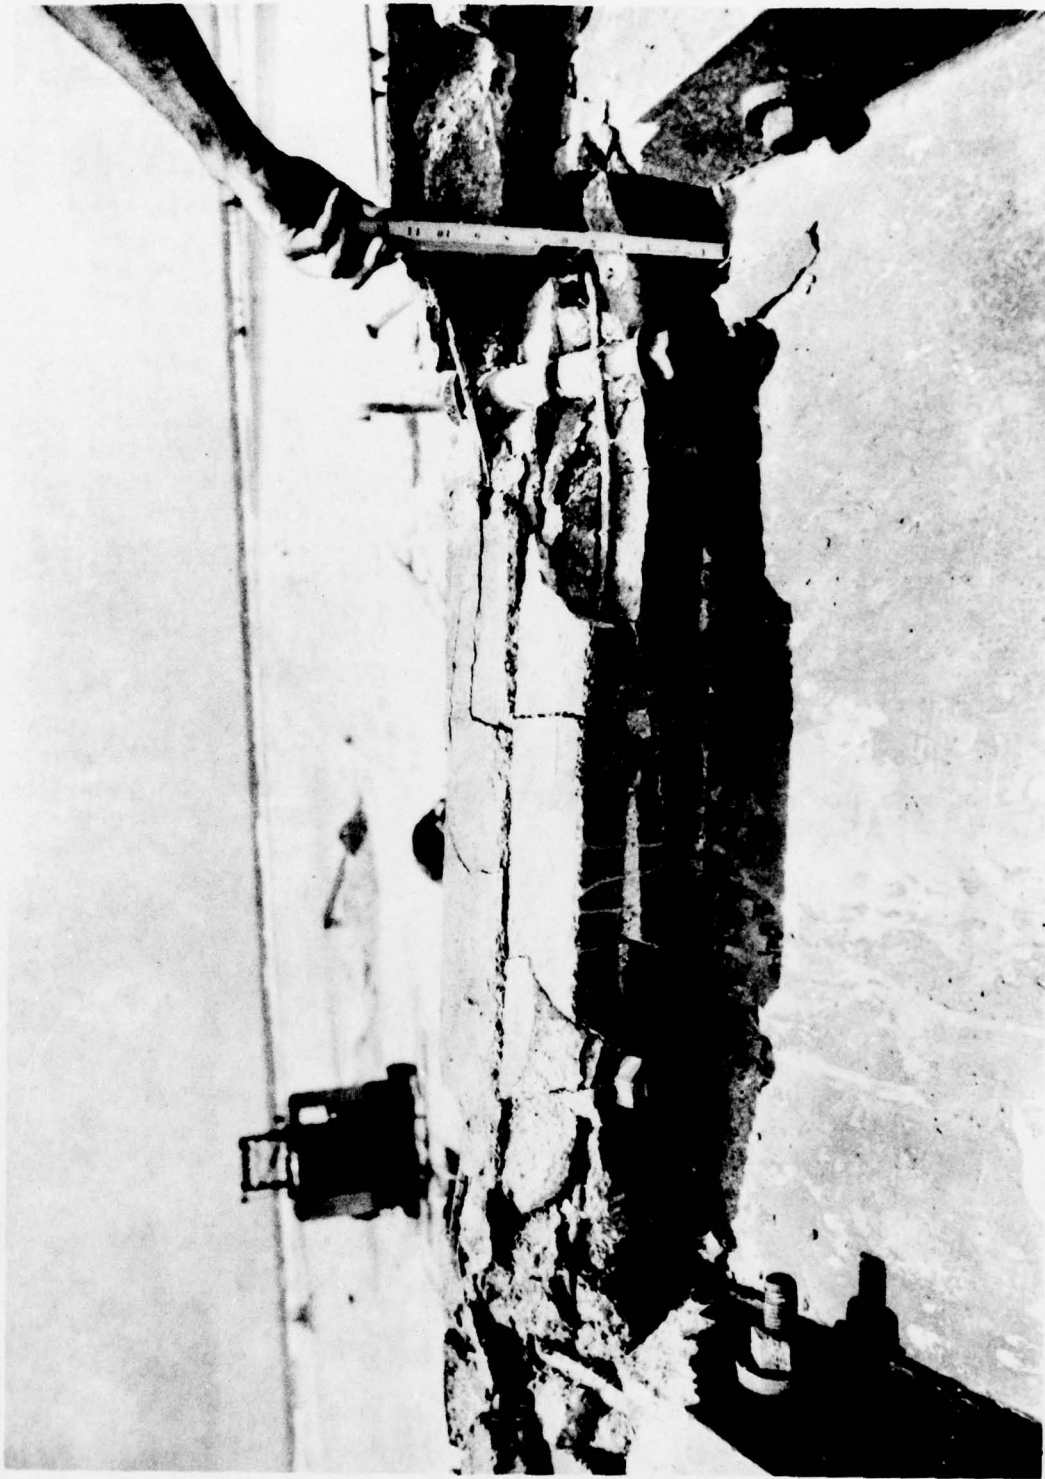
Fig. 6.66 Crown Failure near Center of Building, Showing Downward and Horizontal Displacement of Front Panel

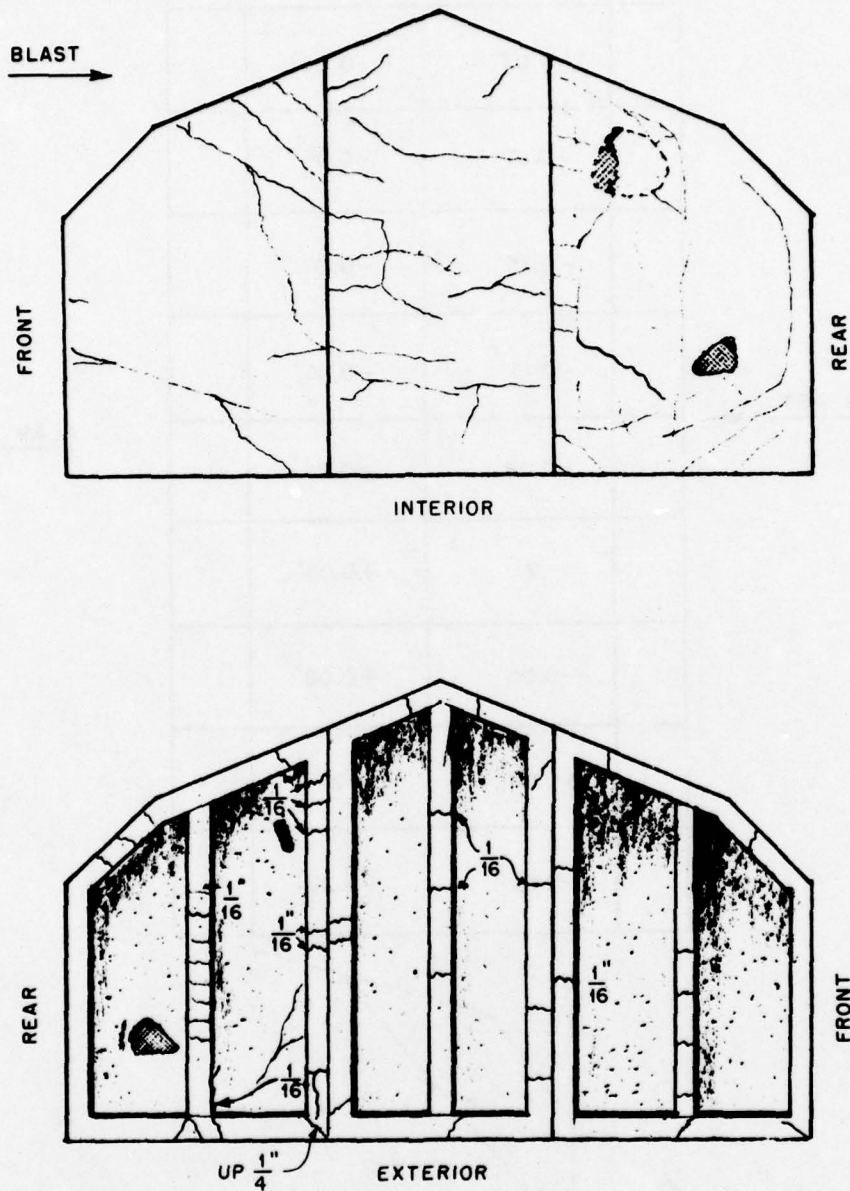
Fig. 6.71 Left-end-wall Crack Patterns, Structure 3.2.4a. Cracks are about $\frac{1}{64}$ in. unless marked.

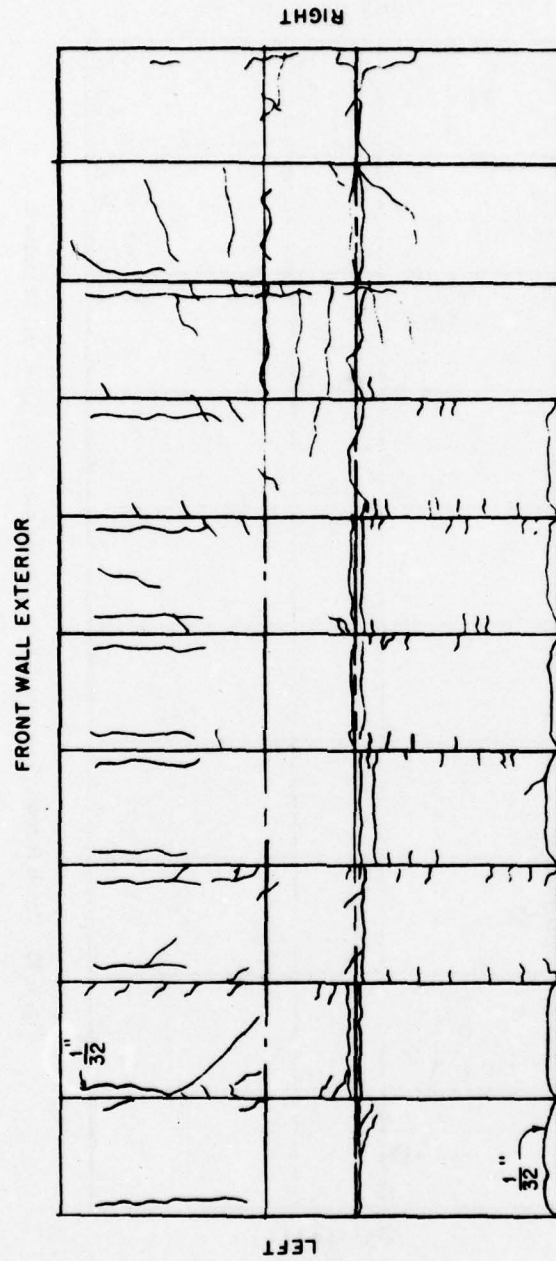
Fig. 6.72 Crack Pattern, Structure 3.2.4a. Cracks are about $\frac{1}{4}$ in. unless marked.

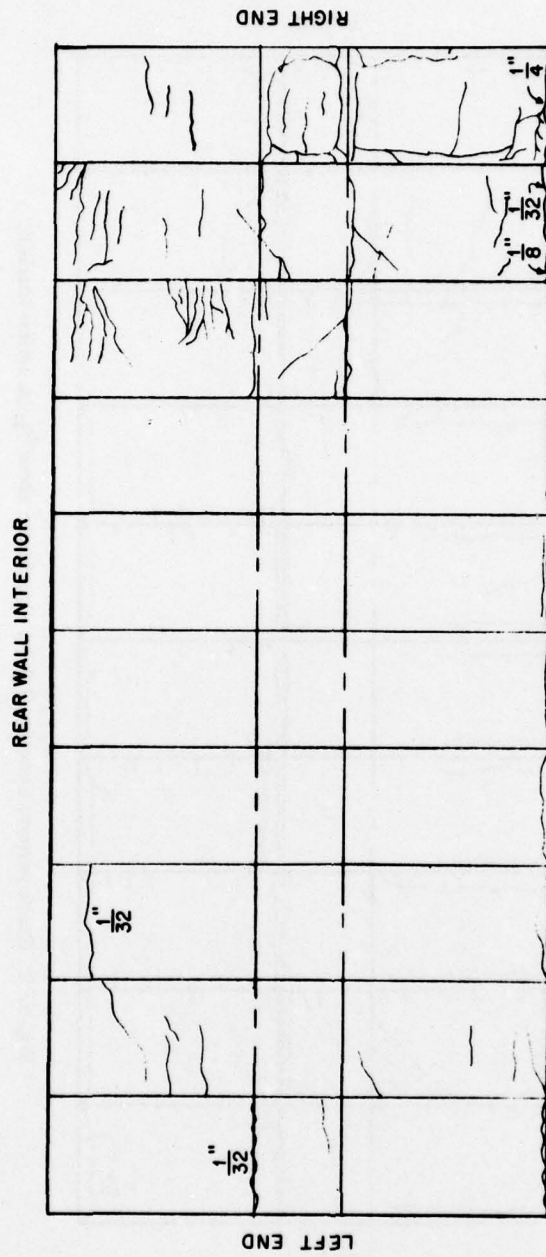
Fig. 6.73 Crack Pattern, Structure 3.2.4a. Cracks are about $\frac{1}{64}$ in. unless marked.

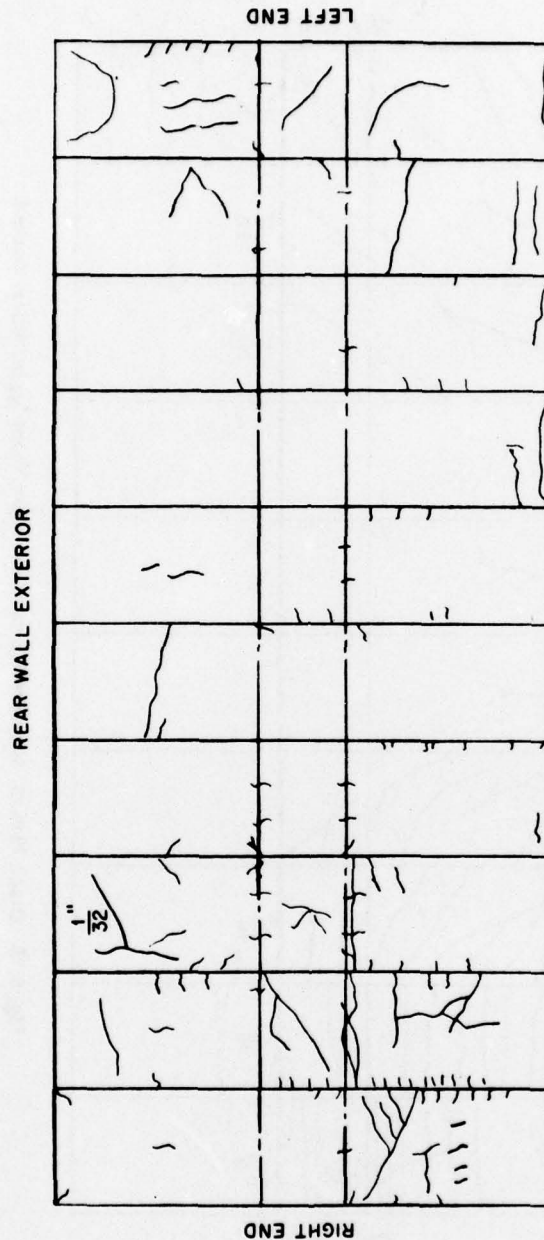
Fig. 6.74 Crack Pattern, Structure 3.2.4a. Cracks are about $\frac{1}{64}$ in. unless marked.

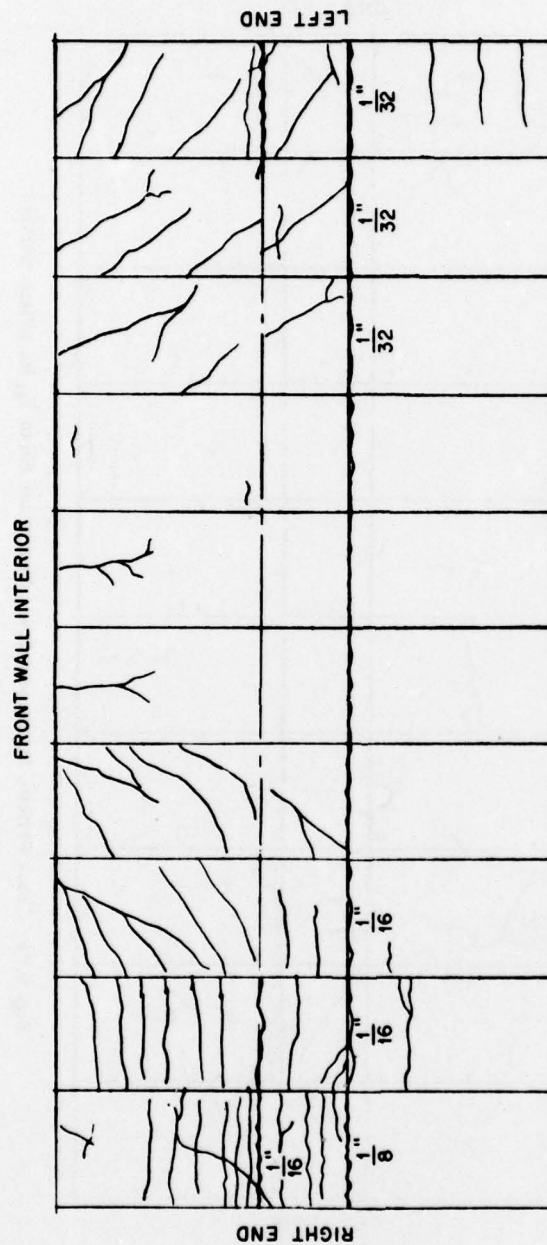
Fig. 6.75 Crack Pattern, Structure 3.2.4a. Cracks are about $\frac{1}{64}$ in. unless marked.

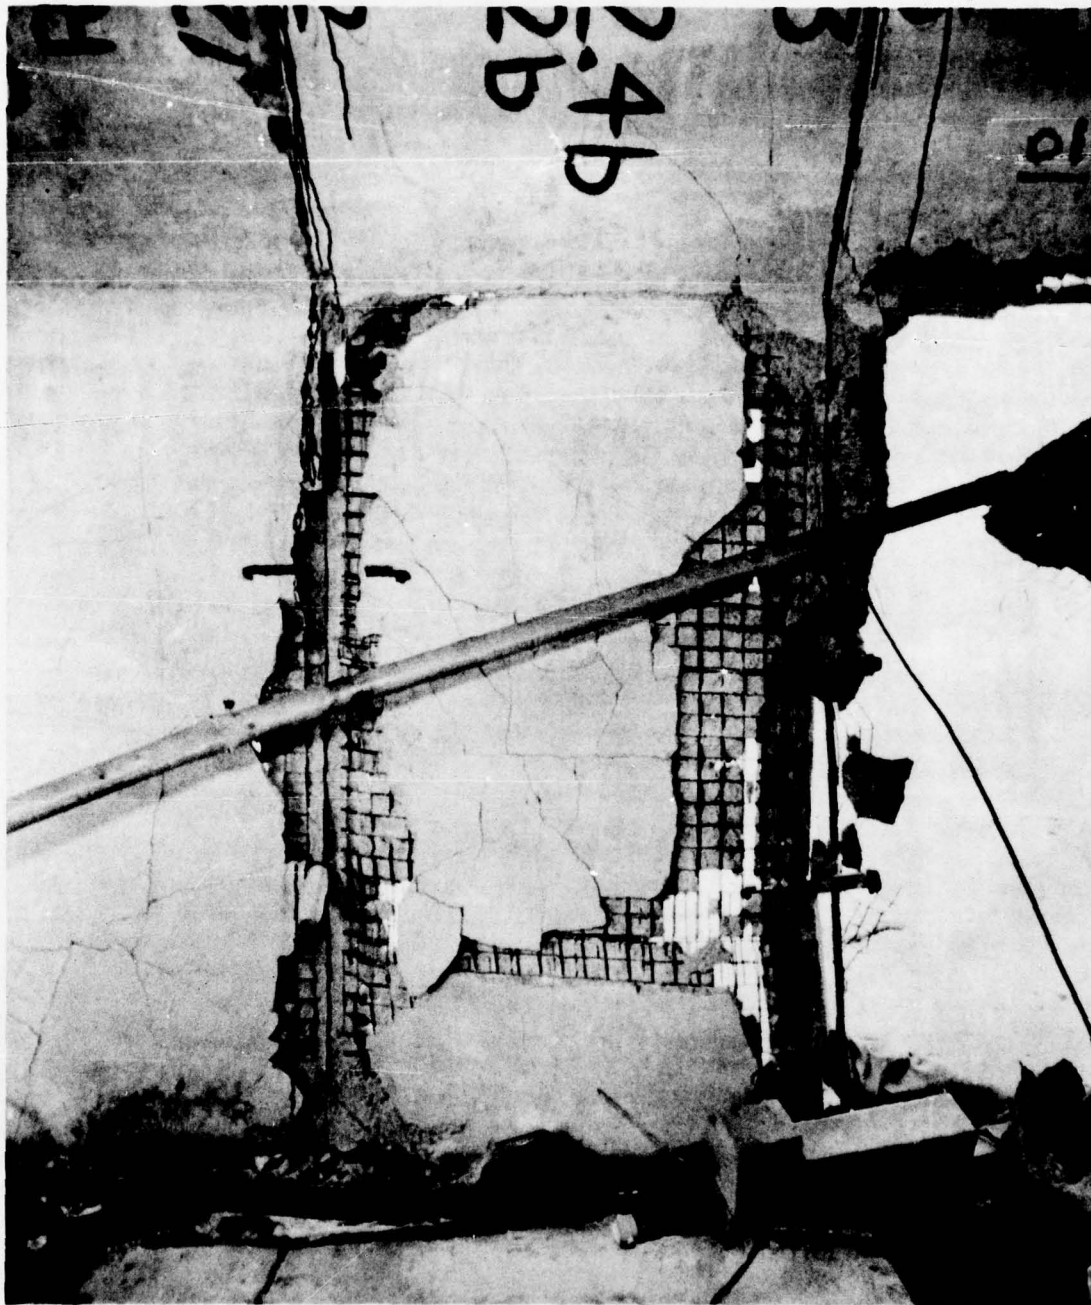
Fig. 6.77 Interior View Showing Diaphragm Distortion and Concrete Spalling After Loading

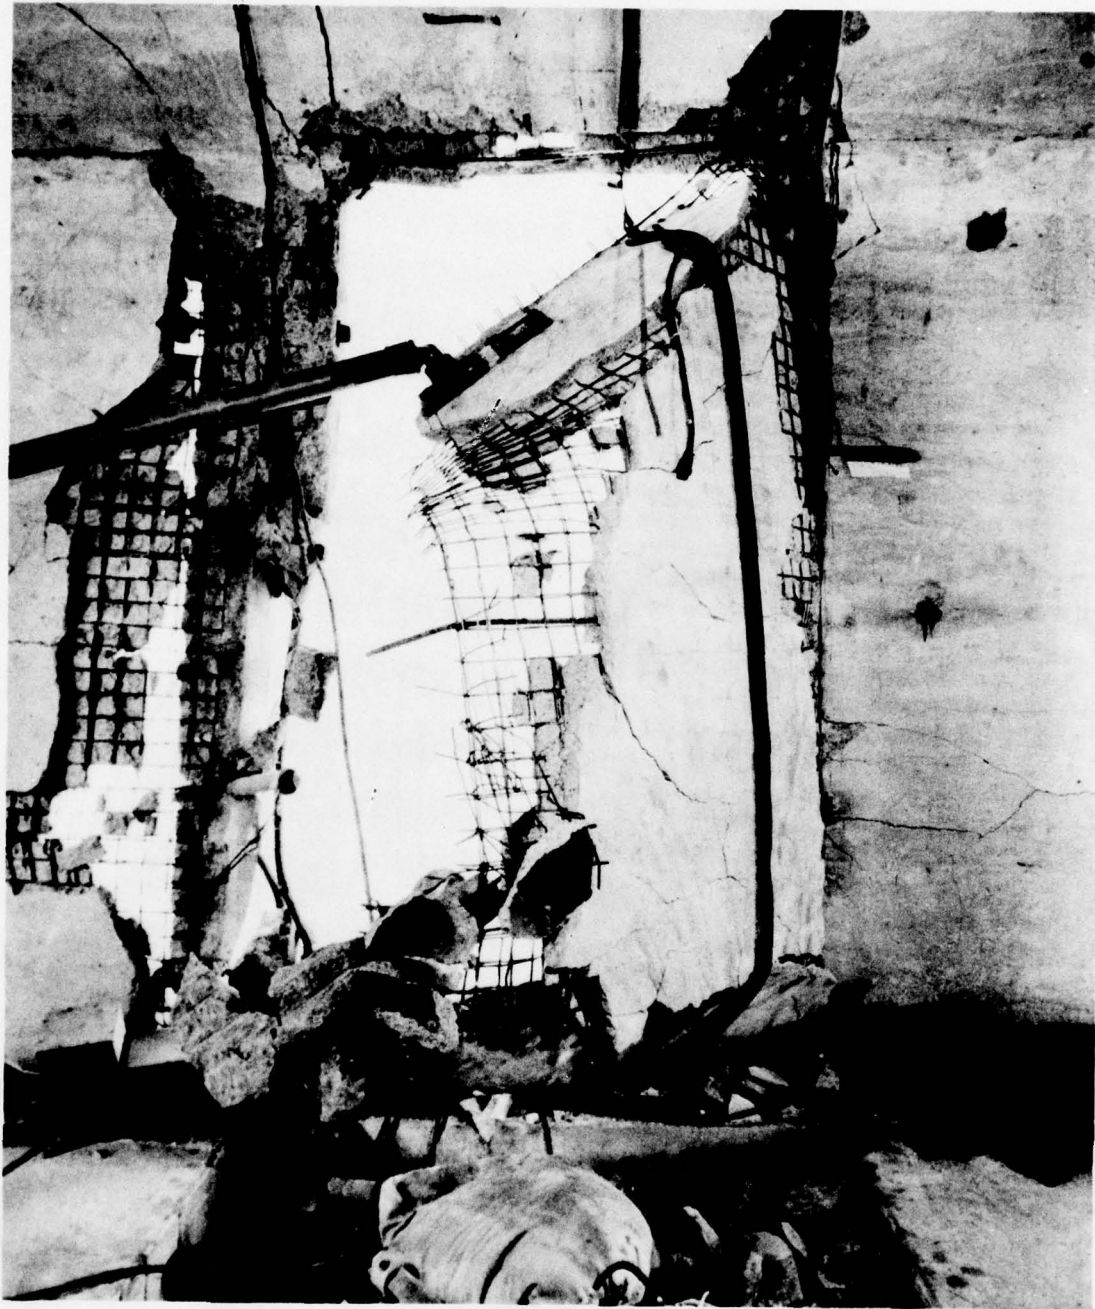
Fig. 6.78 Interior View Showing Failure of Diaphragm After Loading

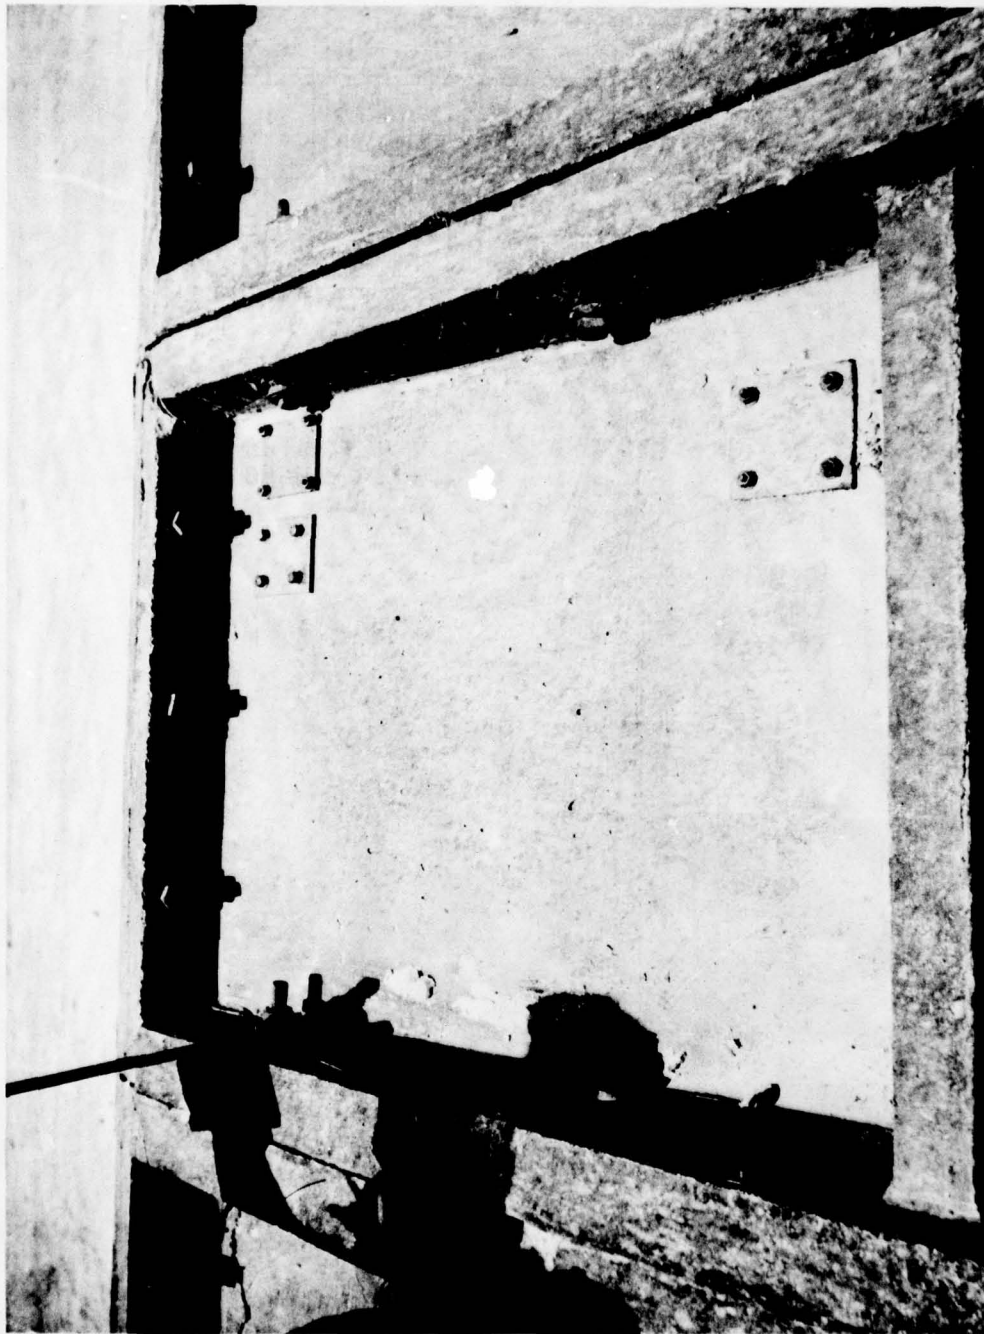
Fig. 6.80 View Showing Roof Failure in Front-wall Panel. Intersection at left is transverse center line of building.

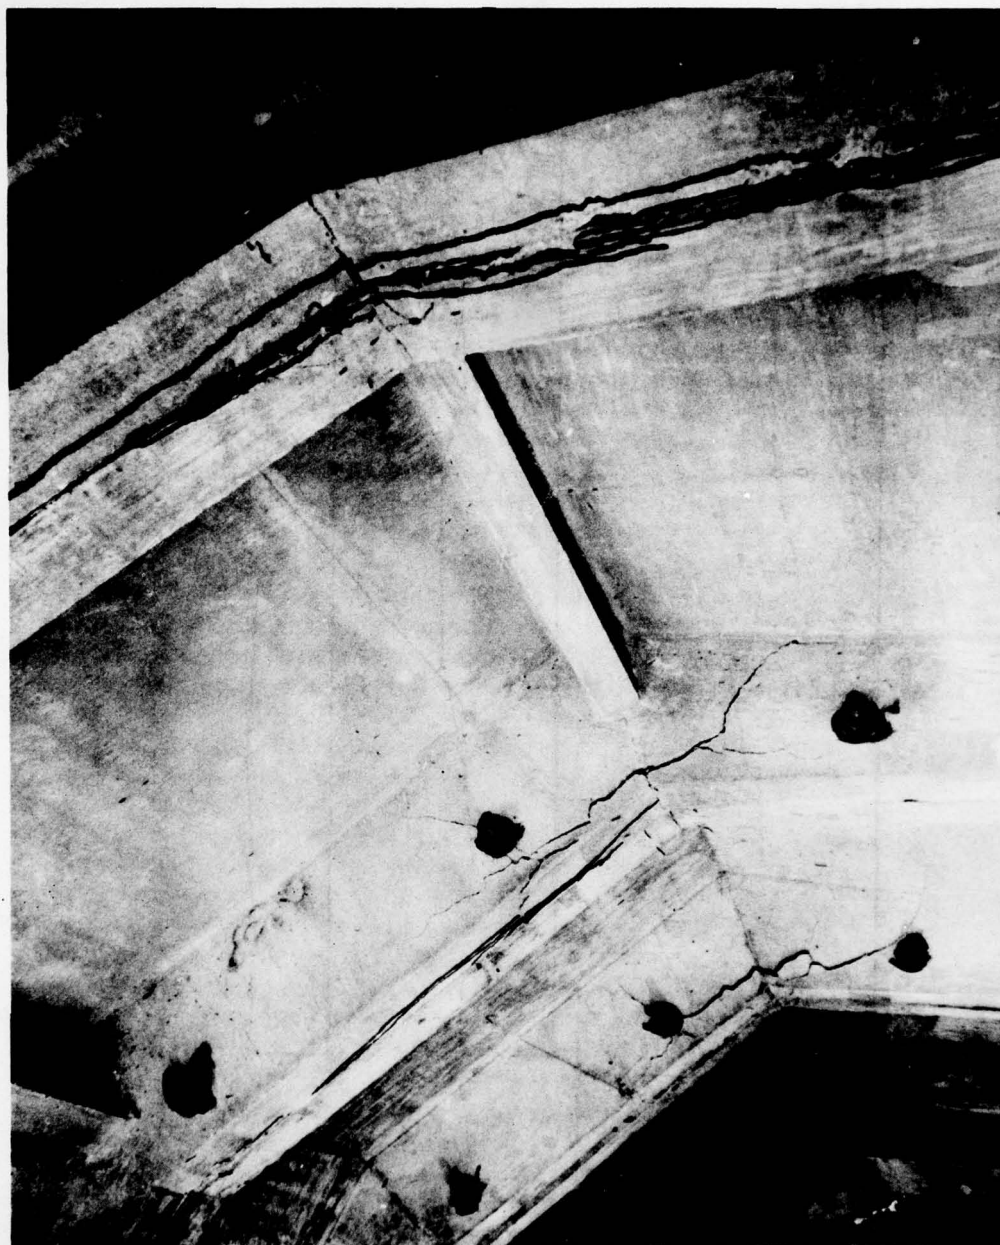
Fig. 6.81 Interior View Showing Cracks in Ribs at Lower Fold of Left Front Wall

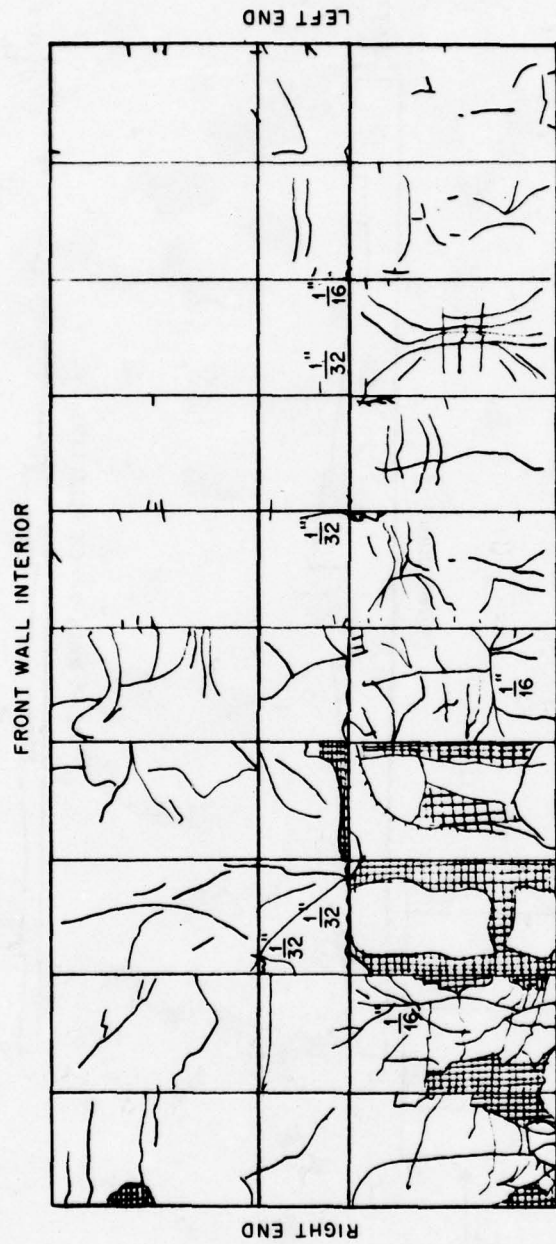
Fig. 6.84 Crack Pattern, Structure 3.2.4b. Cracks are about $\frac{1}{64}$ in. unless marked.

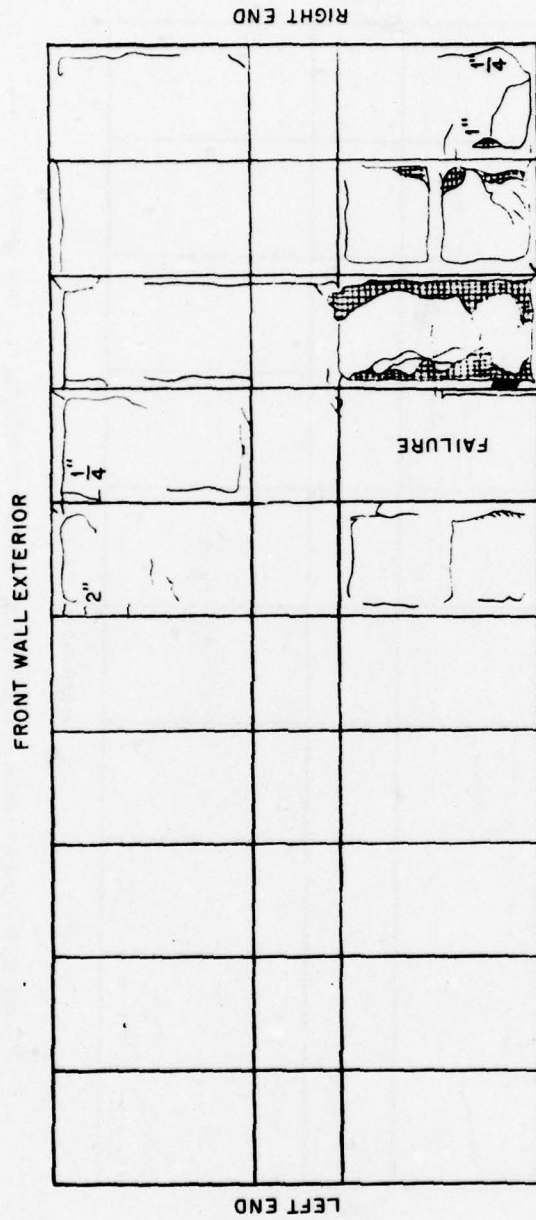
Fig. 6.85 Crack Pattern, Structure 3.2.4b. Cracks are about $\frac{1}{4}$ in. unless marked.

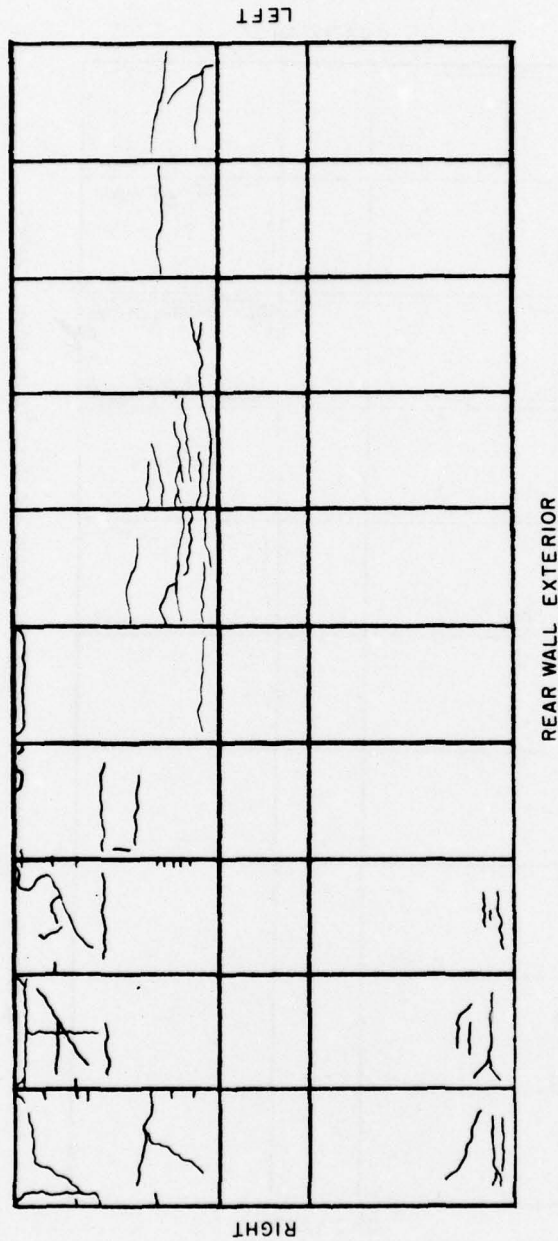
Fig. 6.86 Crack Pattern, Structure 3.2.4b. Cracks are about $\frac{1}{64}$ in. unless marked.

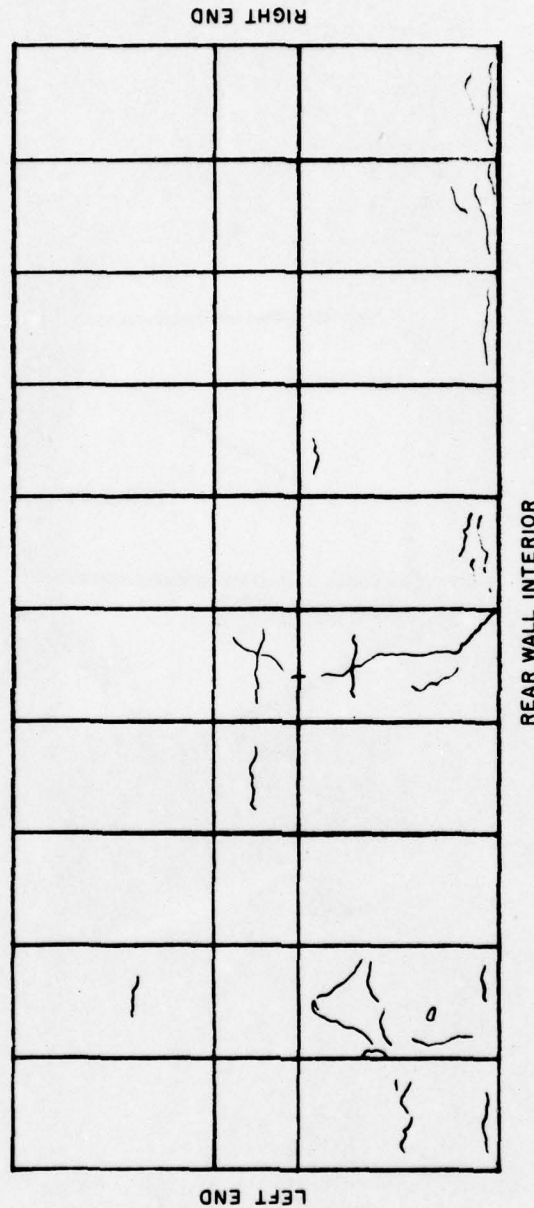
Fig. 6.87 Crack Pattern, Structure 3.2.4b. Cracks are about $\frac{1}{64}$ in. unless marked.

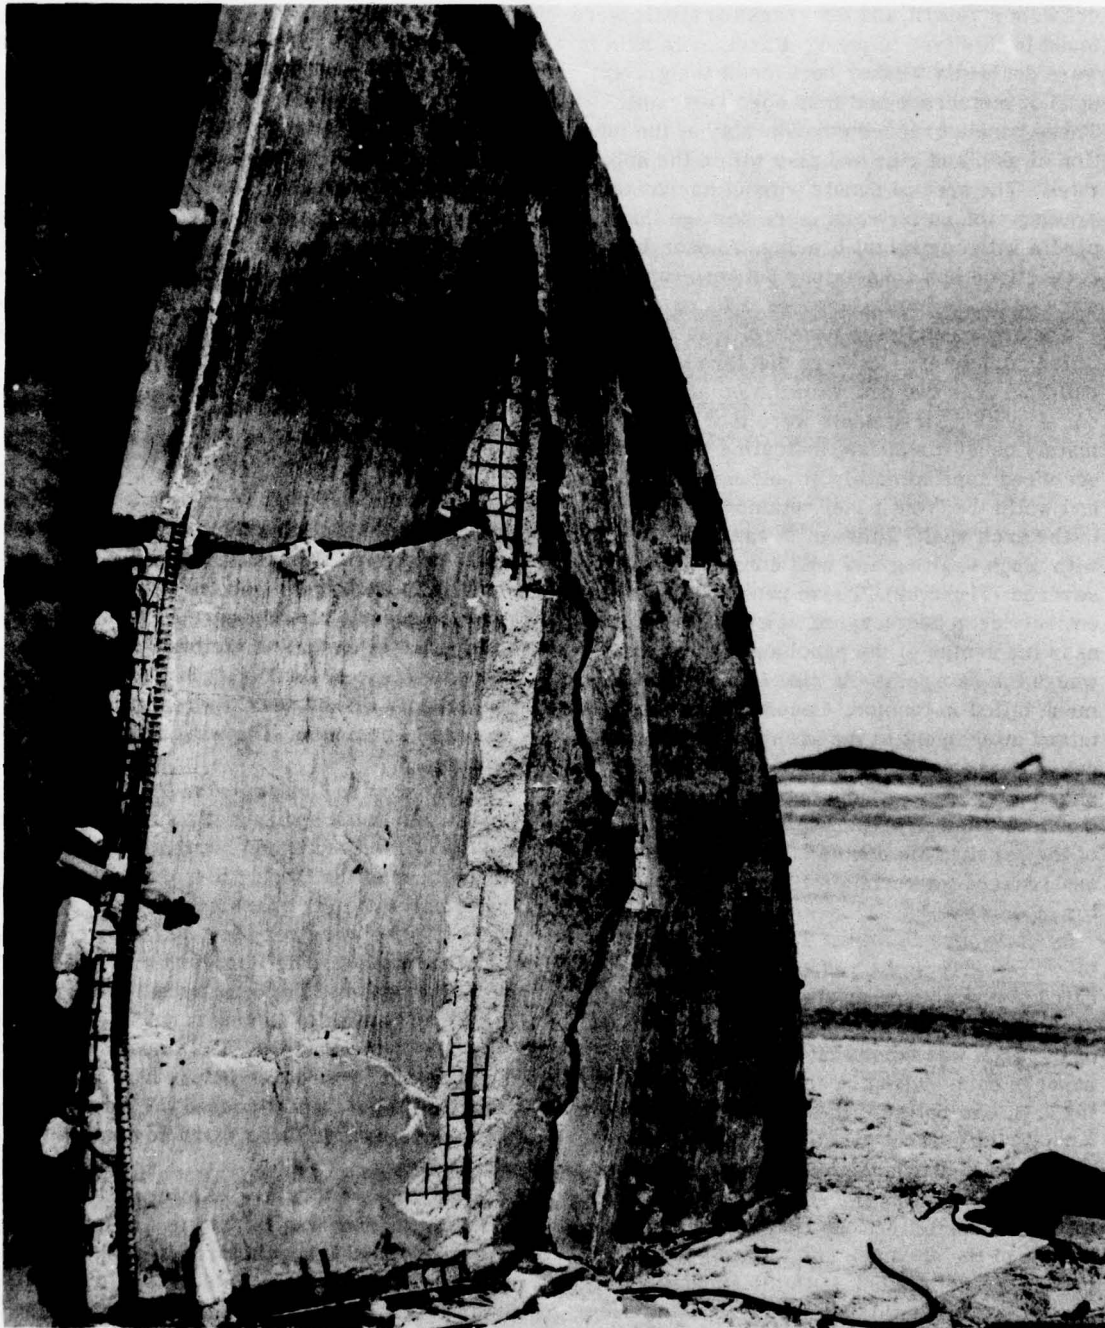
Fig. 6.89 Left End Wall Nearly Severed, Structure 3.2.5
